REPORT NUMBER TR-P28102-01-NC

**NEW CAR ASSESMENT PROGRAM
FRONTAL BARRIER IMPACT TEST**

**MAZDA MOTOR CORPORATION
2008 MAZDA5
5-DOOR PASSENGER CAR**

NHTSA NUMBER: Z85400

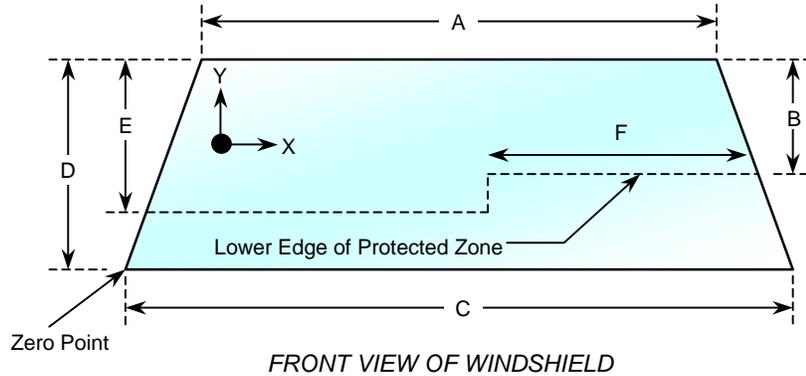
WINDSHIELD AND PROTECTED ZONE

Item	Units	Value
A	mm	1210
B	mm	530
C	mm	1422
D	mm	895
E	mm	583
F	mm	465

There was 100% windshield retention and no intrusion into the protected zone of the windshield during impact. There was no Stoddard solvent leakage after the event, or during any phase of the static rollover.

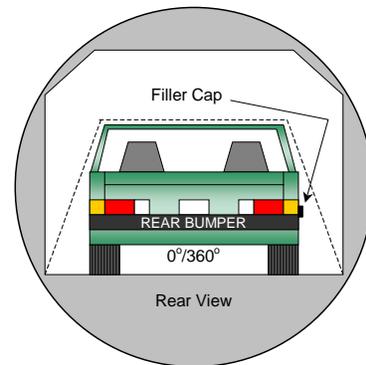
270° to 360°

1. The specified fixture rollover rate for each 90° of rotation is 60 to 120 seconds.
2. The position hold time at each position is 300 seconds (minimum).
3. No solvent leakage occurred during rollover.

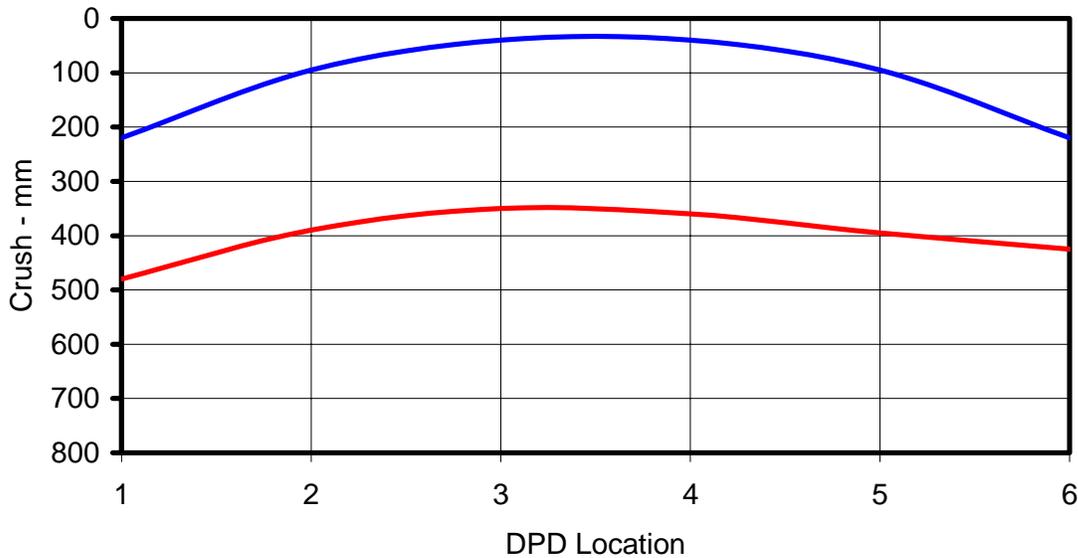
Collision Deformation Classification: 12FDEW6 Midpoint of Damage: Vehicle Centerline
 Damage Region Length: 1735 Impact Mode: Full frontal

No.	Measurement Description	Units	Pre-Test	Post-Test	Difference
C1	Crush zone 1 at left side of vehicle	mm	220	480	-260
C2	Crush zone 2 on left side of vehicle	mm	95	390	-295
C3	Crush zone 3 on left side of vehicle	mm	40	350	-310
C4	Crush zone 4 on right side of vehicle	mm	40	360	-320
C5	Crush zone 5 on right side of vehicle	mm	95	395	-300
C6	Crush zone 6 at right side of vehicle	mm	220	425	-205

The maximum static crush of the vehicle was 560 mm at the vehicle's centerline. Both the driver and passenger side doors remained closed and latched during the impact event, and were operable after the impact.

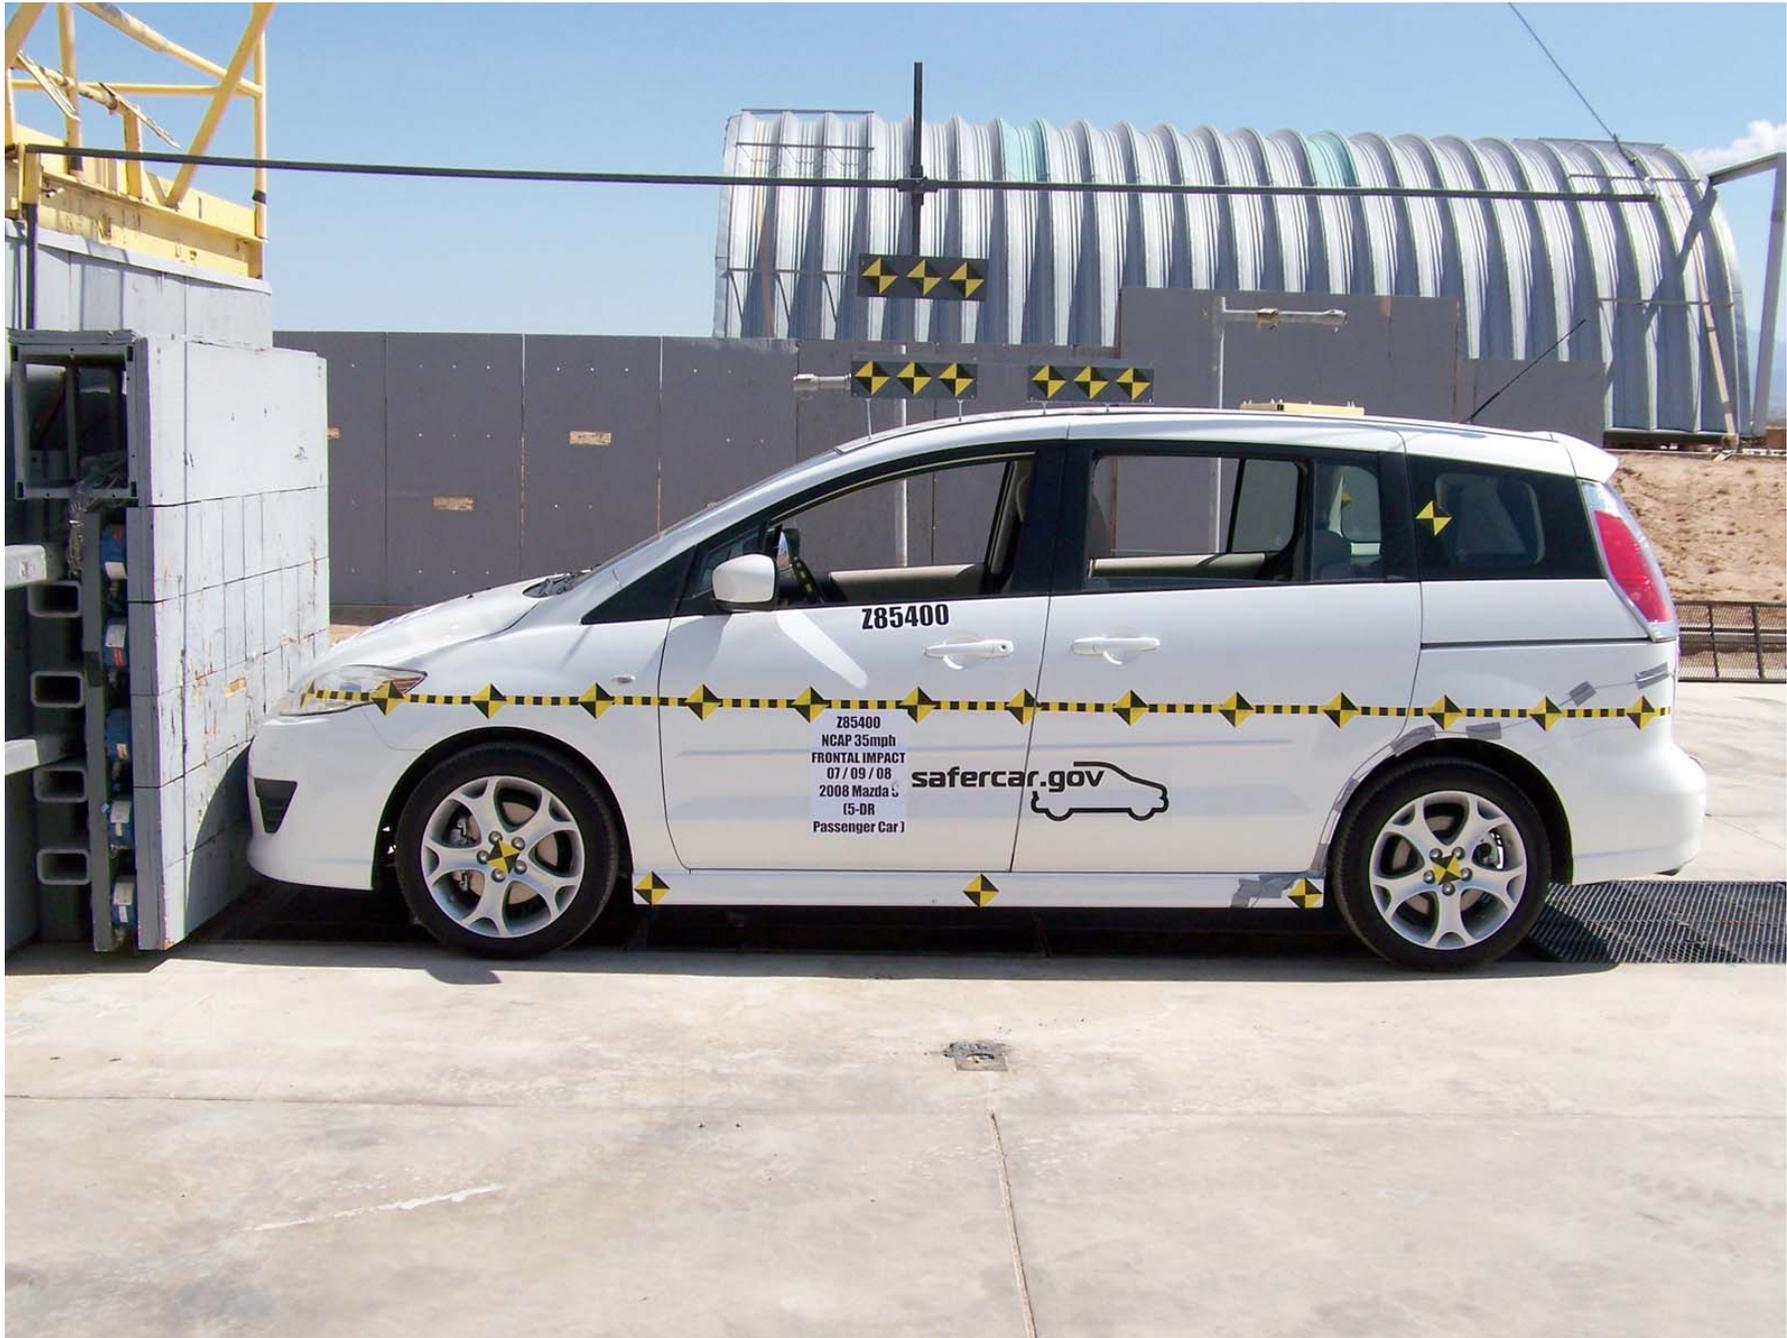
Figure A-7: Post-Test Front View (Vehicle Moved)

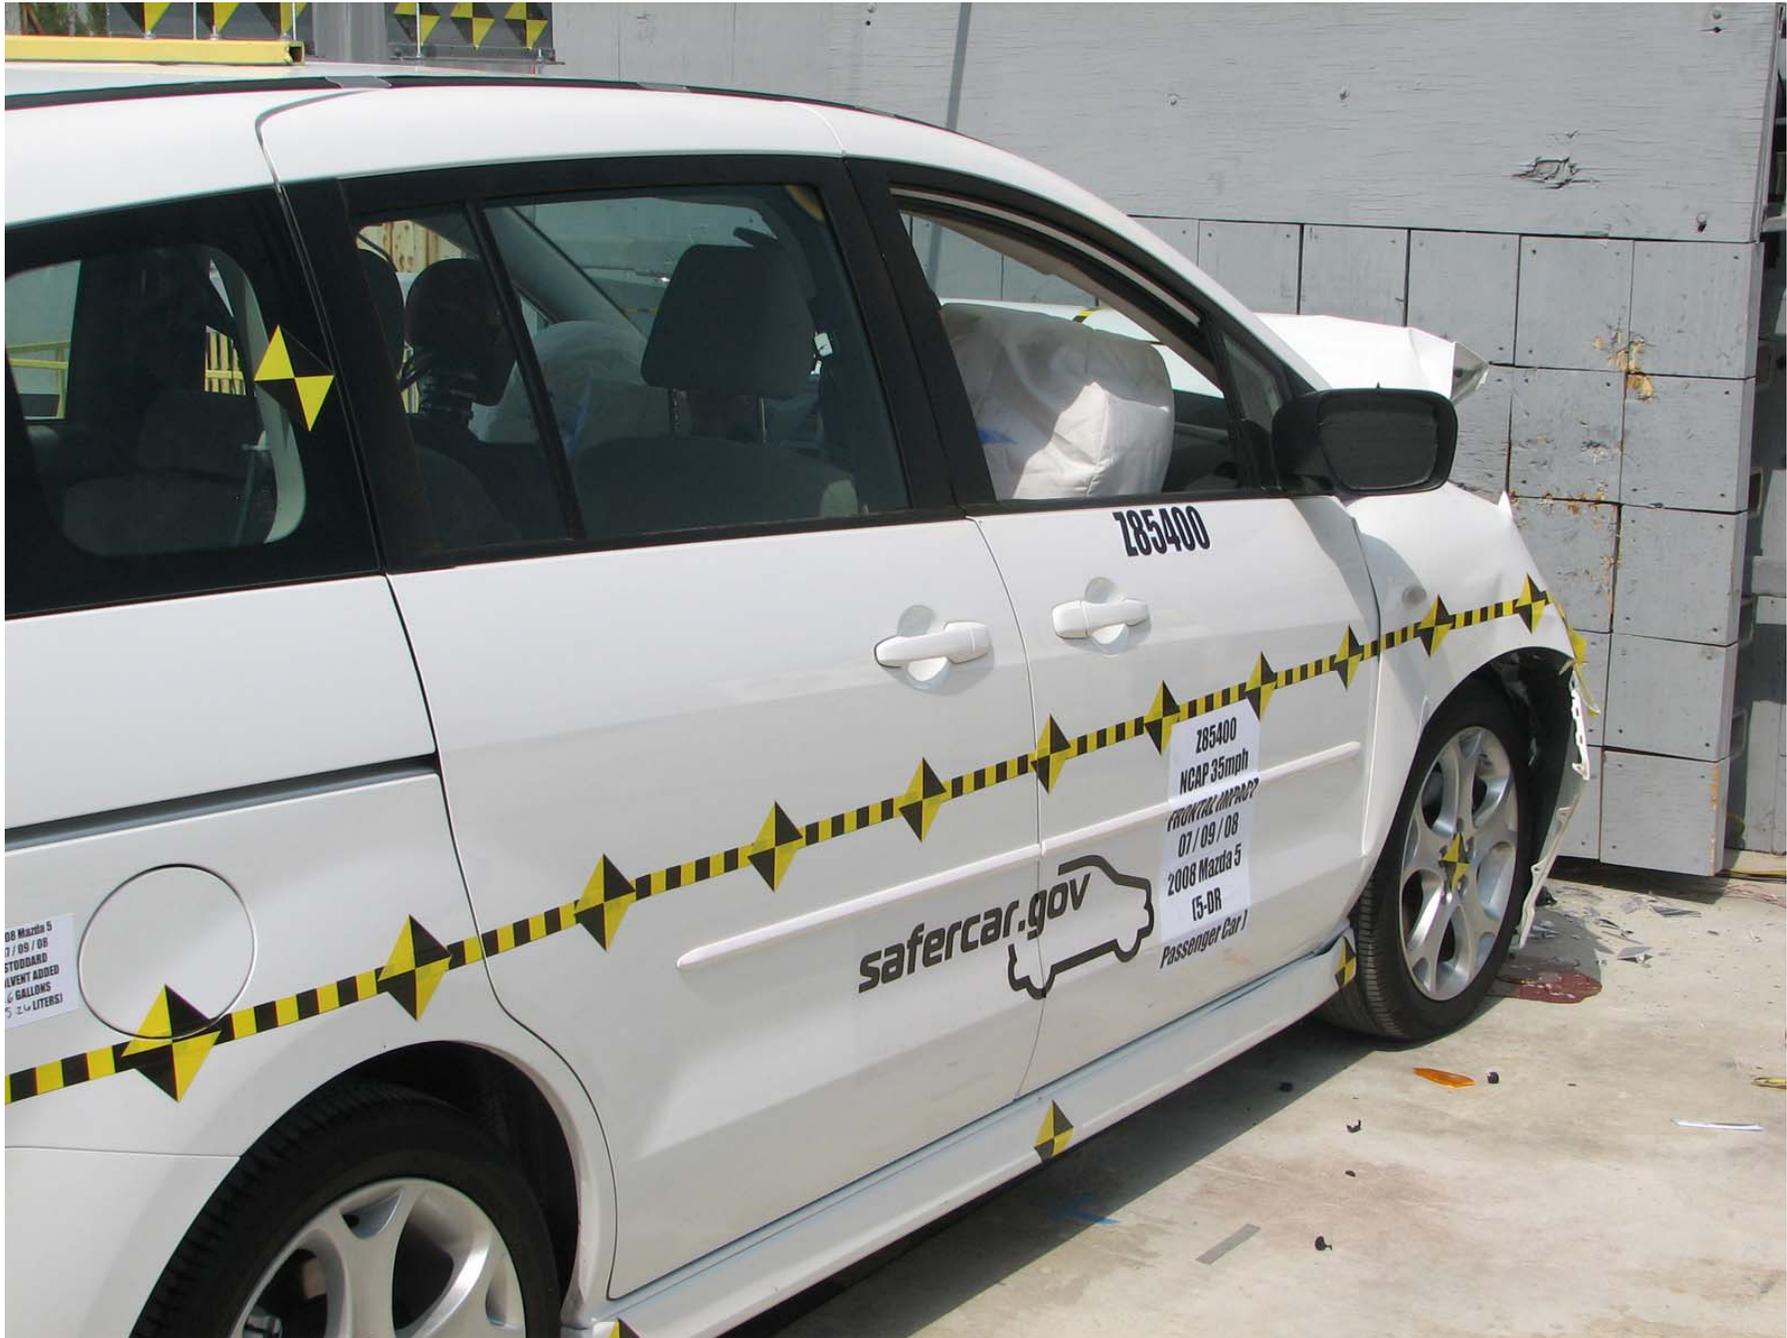
Figure A-16: Post-Test Left Side ¾ View of Doors After Impact

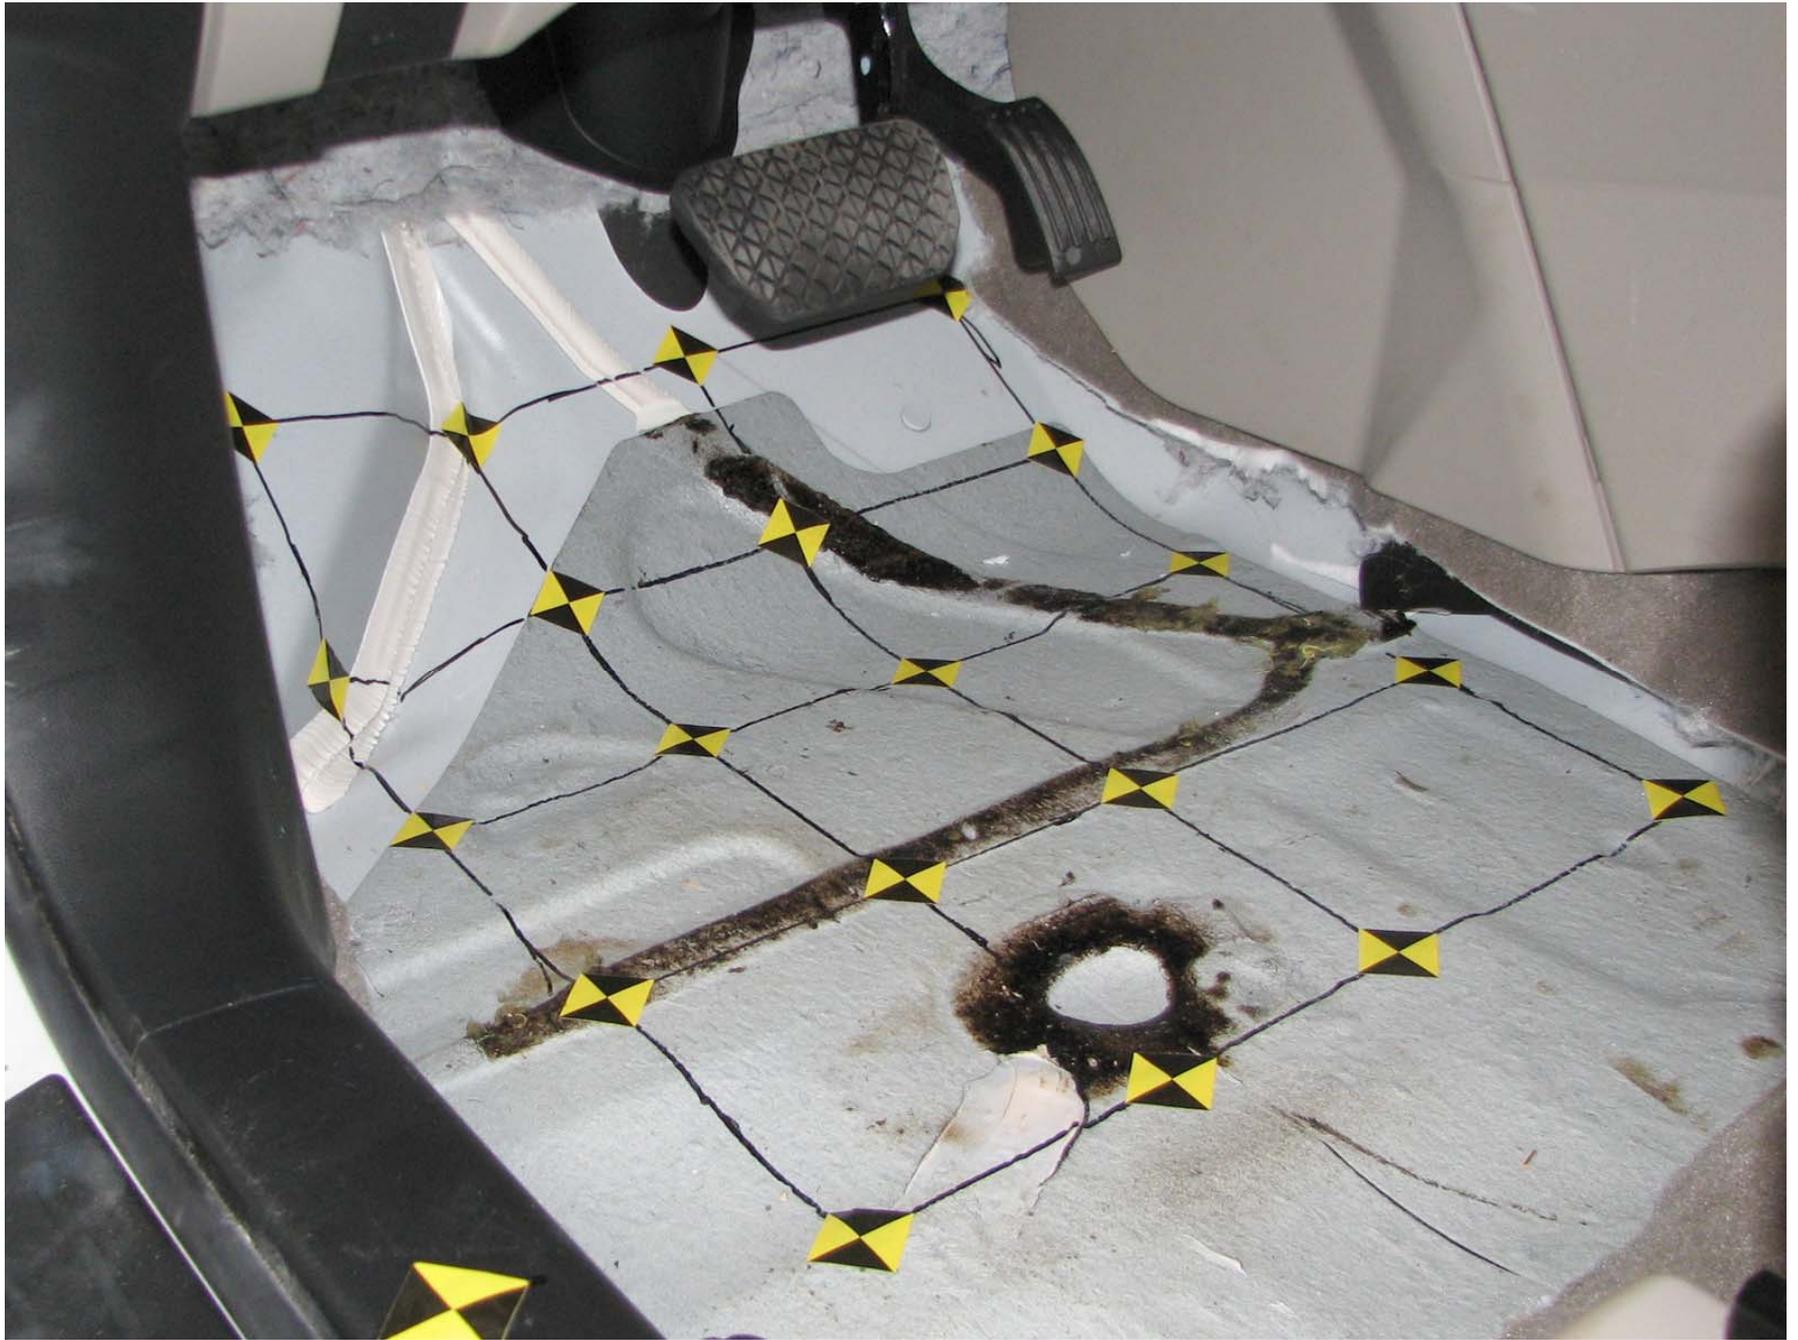
Figure A-39: Post-Test Driver Side Knee Bolster

The driver's visible contact points were as follows: The driver ATD's head, chest, and abdomen contacted the airbag. The head also contacted the headrest. Both knees contacted the bolster.

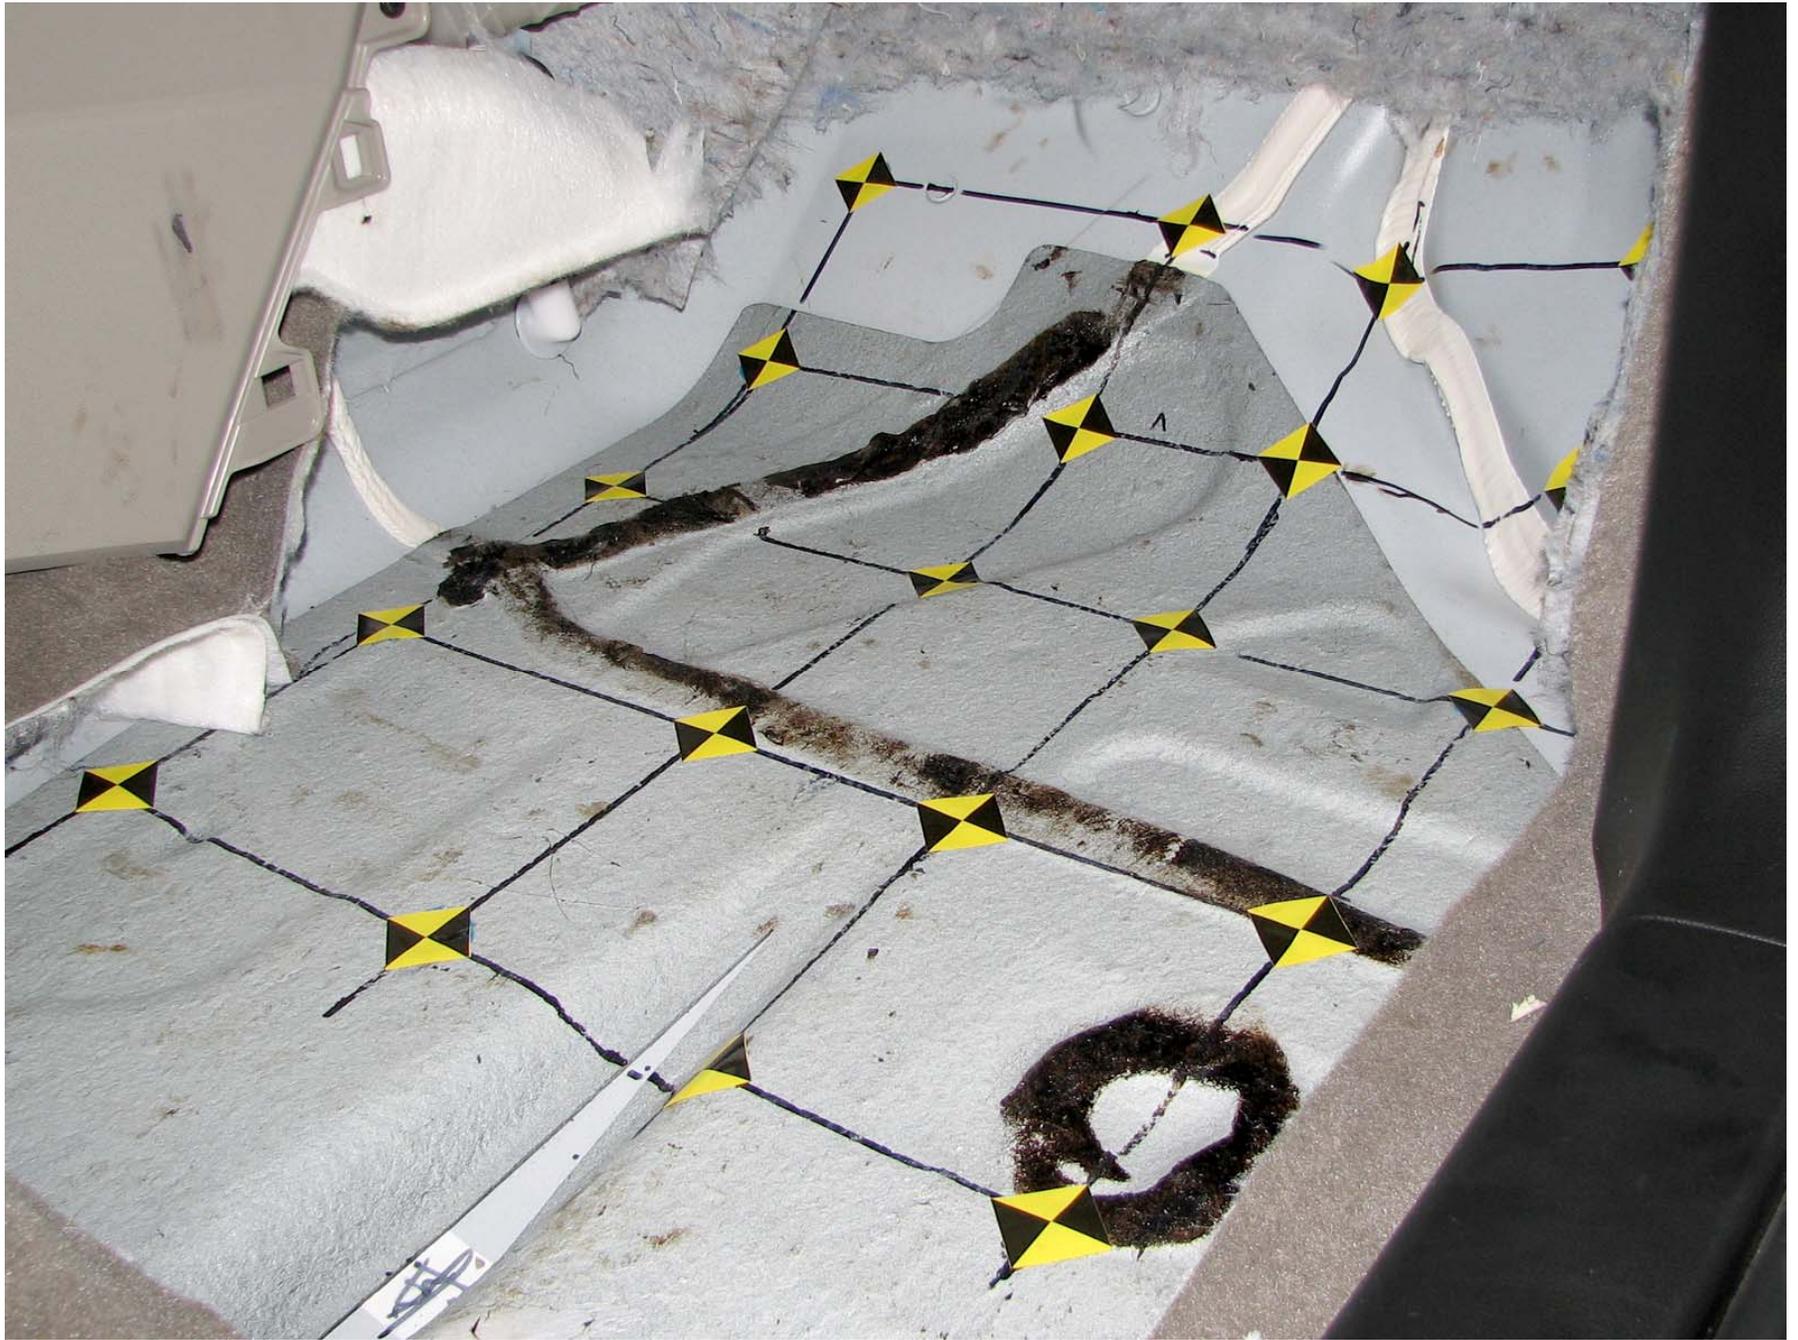
Figure A-53: Post-Test Passenger Side Glove Box

The passenger's visible contact points were as follows: The passenger ATD's head, chest, and abdomen contacted the airbag. The head also contacted the headrest. Both knees contacted the glovebox.

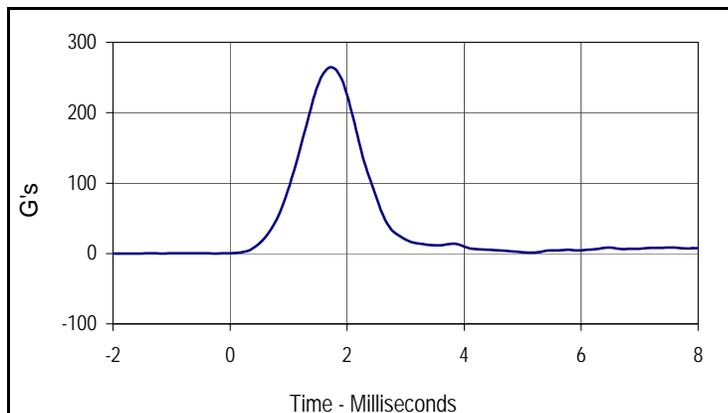
Tested Parameter	Units	Specification	Result	Pass/Fail
Laboratory Temperature	°C	18.9 to 25.6	21.1	Pass
Laboratory Relative Humidity	%	10 to 70	30	Pass
Peak Resultant Acceleration	G's	225.0 to 275.0	264.3	Pass
Peak Lateral Acceleration	G's	≤15.0	4.3	Pass
Is Acceleration Unimodal?	Yes/No	Yes	Yes	Pass
Overall Test Results			Pass

Curve Description			
Head Resultant			
CURNO	Type	SAE Class	Units
001	RES	1000	G's
Max	Time	Min	Time
264.3	1.7	0.0	-0.2

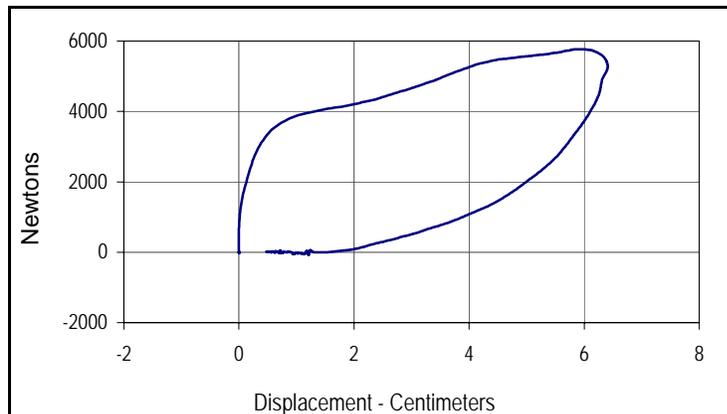
Tested Parameter	Units	Specification	Result	Pass/Fail
Laboratory Temperature	°C	20.6 to 22.2	21.1	Pass
Laboratory Relative Humidity	%	10 to 70	30	Pass
Probe Velocity	m/s	6.58 to 6.82	6.70	Pass
Peak Probe Force	Newtons	5159 to 5893	5763	Pass
Peak Sternum Deflection	CM	6.35 to 7.26	6.41	Pass
Internal Hysteresis	%	69 to 85	76.2	Pass
Overall Test Results				Pass

Curve Description			
Probe Force vs. Chest Deflection			
CURNO	Type	SAE Class	Hysteresis
001	FIL	180	76.2
Peak Probe Force		Peak Chest Deflection	
5763		6.41

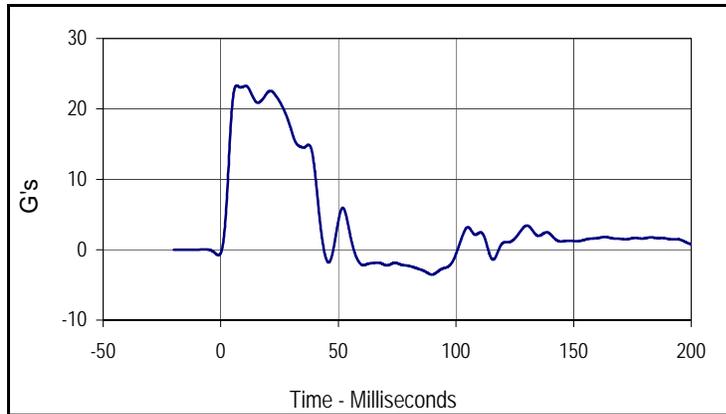
Test Program: Hybrid III 50th Percentile Male Neck Flexion Test

Tested Parameter	Units	Specification	Result	Pass/Fail	
Laboratory Temperature	°C	20.6 to 22.2	21.1	Pass	
Laboratory Relative Humidity	%	10 to 70	30	Pass	
Pendulum Velocity	m/s	6.89 to 7.13	7.04	Pass	
Pendulum Deceleration	10 Msec.	G's	22.5 to 27.5	23.2	Pass
	20 Msec.	G's	17.6 to 22.6	22.4	Pass
	30 Msec.	G's	12.5 to 18.5	17.0	Pass
Peak Pendulum Decel. after 30 Msec.	G's	≤ 29.0	17.0	Pass	
Deceleration Decay, Time to Cross 5 G's	Msec.	34.0 to 42.0	41.9	Pass	
Maximum "D" Plane Rotation	Max	Degrees	64.0 to 78.0	71.6	Pass
	Time	Msec.	57.0 to 64.0	62.8	Pass
"D" Plane Rotation Decay, Time To Zero Crossing	Msec.	113.0 to 128.0	115.3	Pass	
Moment About Occ. Condyle	Max	Nm	84.1 to 108.5	96.5	Pass
	Time	Msec.	47.0 to 58.0	52.1	Pass
Positive Moment Decay, Time To Zero Crossing	Msec.	97.0 to 107.0	97.0	Pass	
Overall Test Results				Pass

Curve Description			
Pendulum Deceleration			
CURNO	Type	SAE Class	Units
001	FIL	60	G's
Max	Time	Min	Time
23.3	6.7	-3.5	89.8

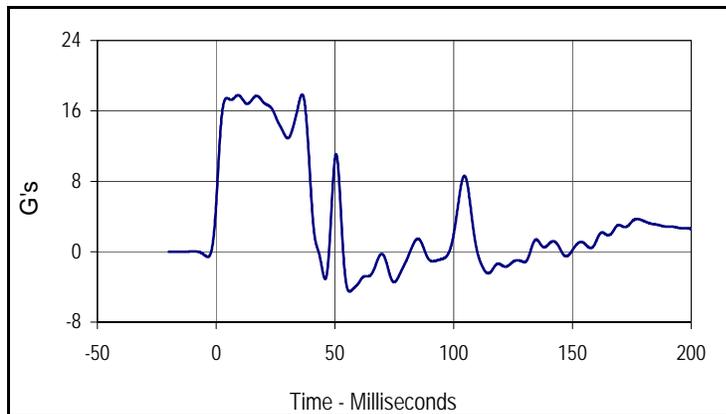
Tested Parameter	Units	Specification	Result	Pass/Fail	
Laboratory Temperature	°C	20.6 to 22.2	21.1	Pass	
Laboratory Relative Humidity	%	10 to 70	30	Pass	
Pendulum Velocity	m/s	5.94 to 6.19	6.16	Pass	
Pendulum Deceleration	10 Msec.	G's	17.2 to 21.2	17.7	Pass
	20 Msec.	G's	14.0 to 19.0	16.9	Pass
	30 Msec.	G's	11.0 to 16.0	12.9	Pass
Peak Pendulum Decel. after 30 Msec.	G's	≤ 22.0	17.9	Pass	
Deceleration Decay, Time to Cross 5 G's	Msec.	38.0 to 46.0	40.4	Pass	
Maximum "D" Plane Rotation	Max	Degrees	81.0 to 106.0	91.4	Pass
	Time	Msec.	72.0 to 82.0	81.4	Pass
"D" Plane Rotation Decay, Time To Zero Crossing	Msec.	147.0 to 174.0	156.6	Pass	
Moment About Occ. Condyle	Max	Nm	-52.9 to- 79.9	-74.1	Pass
	Time	Msec.	65.0 to 79.0	70.5	Pass
Positive Moment Decay, Time To Zero Crossing	Msec.	120.0 to 148.0	142.7	Pass	
Overall Test Results				Pass

Curve Description			
Pendulum Deceleration			
CURNO	Type	SAE Class	Units
001	FIL	60	G's
Max	Time	Min	Time
17.9	36.2	-4.5	56.1

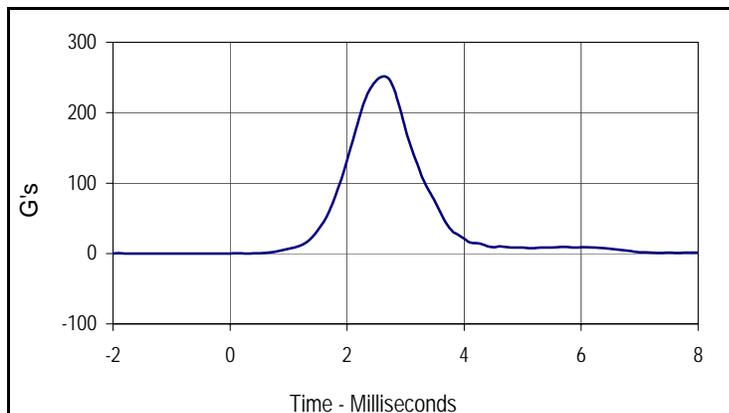
Tested Parameter	Units	Specification	Result	Pass/Fail
Laboratory Temperature	°C	18.9 to 25.6	21.1	Pass
Laboratory Relative Humidity	%	10 to 70	30	Pass
Peak Resultant Acceleration	G's	225.0 to 275.0	251.0	Pass
Peak Lateral Acceleration	G's	≤15.0	3.7	Pass
Is Acceleration Unimodal?	Yes/No	Yes	Yes	Pass
Overall Test Results			Pass

Curve Description			
Head Resultant			
CURNO	Type	SAE Class	Units
001	RES	1000	G's
Max	Time	Min	Time
251.0	2.6	0.0	-1.7

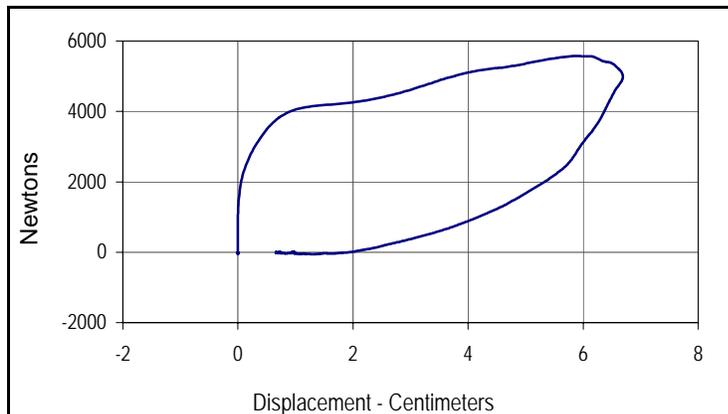
Tested Parameter	Units	Specification	Result	Pass/Fail
Laboratory Temperature	°C	20.6 to 22.2	21.1	Pass
Laboratory Relative Humidity	%	10 to 70	30	Pass
Probe Velocity	m/s	6.58 to 6.82	6.69	Pass
Peak Probe Force	Newtons	5159 to 5893	5574	Pass
Peak Sternum Deflection	CM	6.35 to 7.26	6.69	Pass
Internal Hysteresis	%	69 to 85	77.5	Pass
Overall Test Results				Pass

Curve Description			
Probe Force vs. Chest Deflection			
CURNO	Type	SAE Class	Hysteresis
001	FIL	180	77.5
Peak Probe Force		Peak Chest Deflection	
5574		6.69

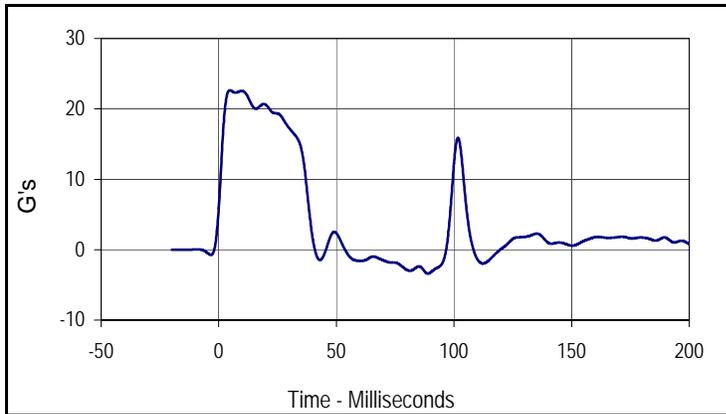
Tested Parameter	Units	Specification	Result	Pass/Fail	
Laboratory Temperature	°C	20.6 to 22.2	21.1	Pass	
Laboratory Relative Humidity	%	10 to 70	30	Pass	
Pendulum Velocity	m/s	6.89 to 7.13	7.04	Pass	
Pendulum Deceleration	10 Msec.	G's	22.5 to 27.5	22.5	Pass
	20 Msec.	G's	17.6 to 22.6	20.6	Pass
	30 Msec.	G's	12.5 to 18.5	17.2	Pass
Peak Pendulum Decel. after 30 Msec.	G's	≤ 29.0	17.2	Pass	
Deceleration Decay, Time to Cross 5 G's	Msec.	34.0 to 42.0	38.6	Pass	
Maximum "D" Plane Rotation	Max	Degrees	64.0 to 78.0	76.9	Pass
	Time	Msec.	57.0 to 64.0	62.3	Pass
"D" Plane Rotation Decay, Time To Zero Crossing	Msec.	113.0 to 128.0	120.6	Pass	
Moment About Occ. Condyle	Max	Nm	84.1 to 108.5	96.4	Pass
	Time	Msec.	47.0 to 58.0	49.9	Pass
Positive Moment Decay, Time To Zero Crossing	Msec.	97.0 to 107.0	101.9	Pass	
Overall Test Results				Pass

Curve Description			
Pendulum Deceleration			
CURNO	Type	SAE Class	Units
001	FIL	60	G's
Max	Time	Min	Time
22.6	4.7	-3.4	88.9

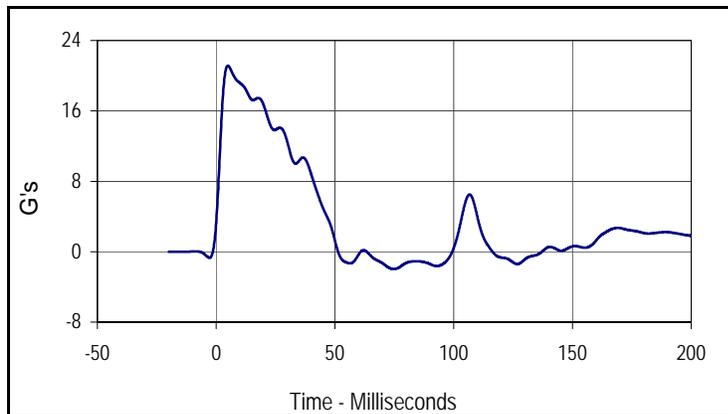
Tested Parameter	Units	Specification	Result	Pass/Fail	
Laboratory Temperature	°C	20.6 to 22.2	21.1	Pass	
Laboratory Relative Humidity	%	10 to 70	30	Pass	
Pendulum Velocity	m/s	5.94 to 6.19	6.16	Pass	
Pendulum Deceleration	10 Msec.	G's	17.2 to 21.2	19.2	Pass
	20 Msec.	G's	14.0 to 19.0	16.7	Pass
	30 Msec.	G's	11.0 to 16.0	12.4	Pass
Peak Pendulum Decel. after 30 Msec.	G's	≤ 22.0	12.4	Pass	
Deceleration Decay, Time to Cross 5 G's	Msec.	38.0 to 46.0	45.0	Pass	
Maximum "D" Plane Rotation	Max	Degrees	81.0 to 106.0	92.2	Pass
	Time	Msec.	72.0 to 82.0	76.1	Pass
"D" Plane Rotation Decay, Time To Zero Crossing	Msec.	147.0 to 174.0	153.8	Pass	
Moment About Occ. Condyle	Max	Nm	-52.9 to- 79.9	-58.8	Pass
	Time	Msec.	65.0 to 79.0	66.6	Pass
Positive Moment Decay, Time To Zero Crossing	Msec.	120.0 to 148.0	146.4	Pass	
Overall Test Results				Pass

Curve Description			
Pendulum Deceleration			
CURNO	Type	SAE Class	Units
001	FIL	60	G's
Max	Time	Min	Time
21.1	4.9	-2.0	74.7
